# Flood Investigation Report

Devon Floods 21<sup>st</sup> – 25<sup>th</sup> November 2012

Final Report

This flood investigation report has been produced by Devon County Council as a Lead Local Flood Authority under Section 19 of the Flood and Water Management Act 2010

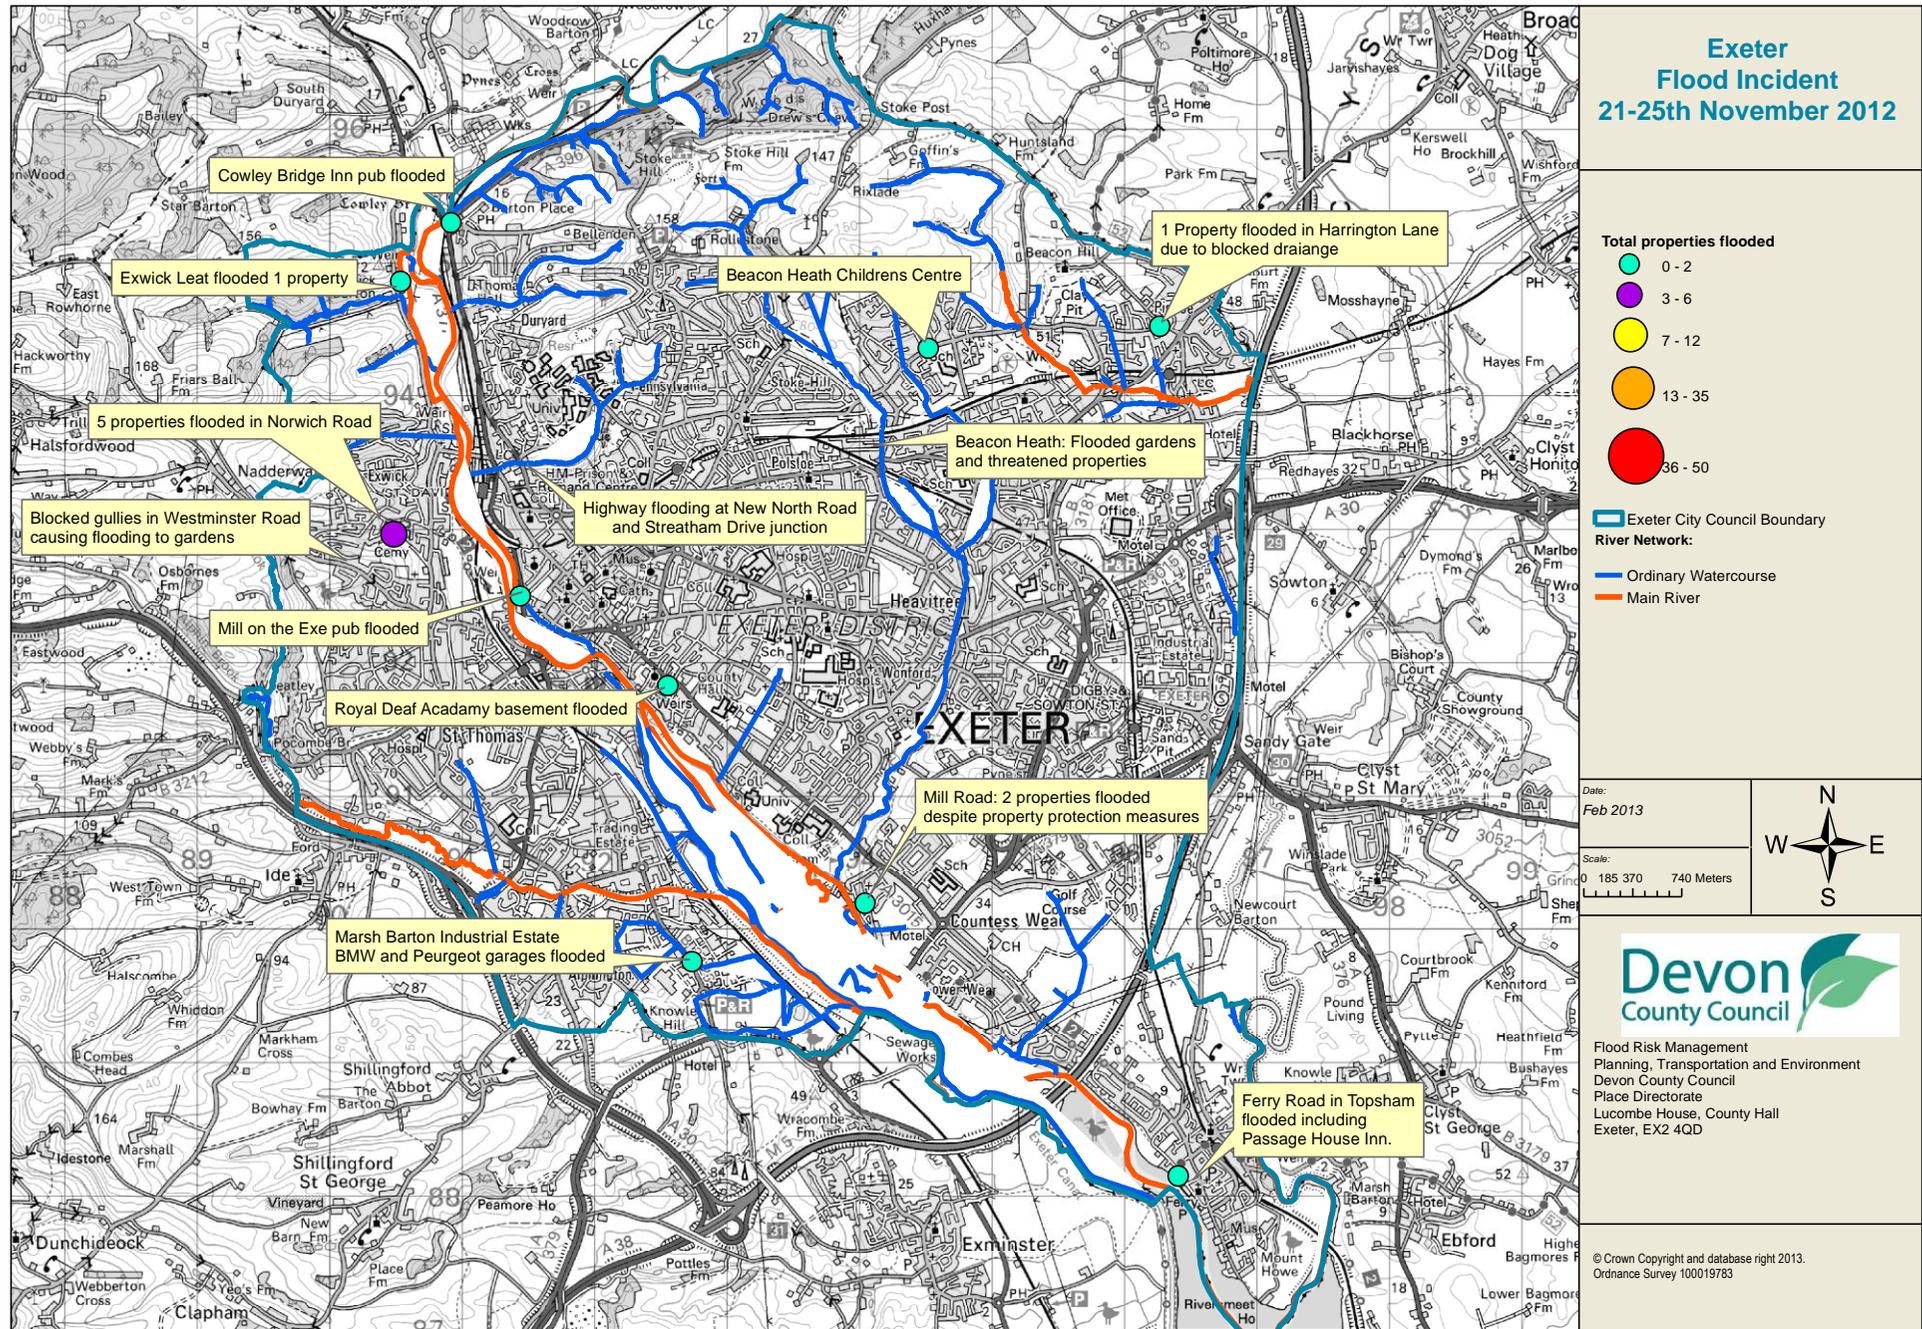
Figure 7.1. November flood extent and impact in Exeter

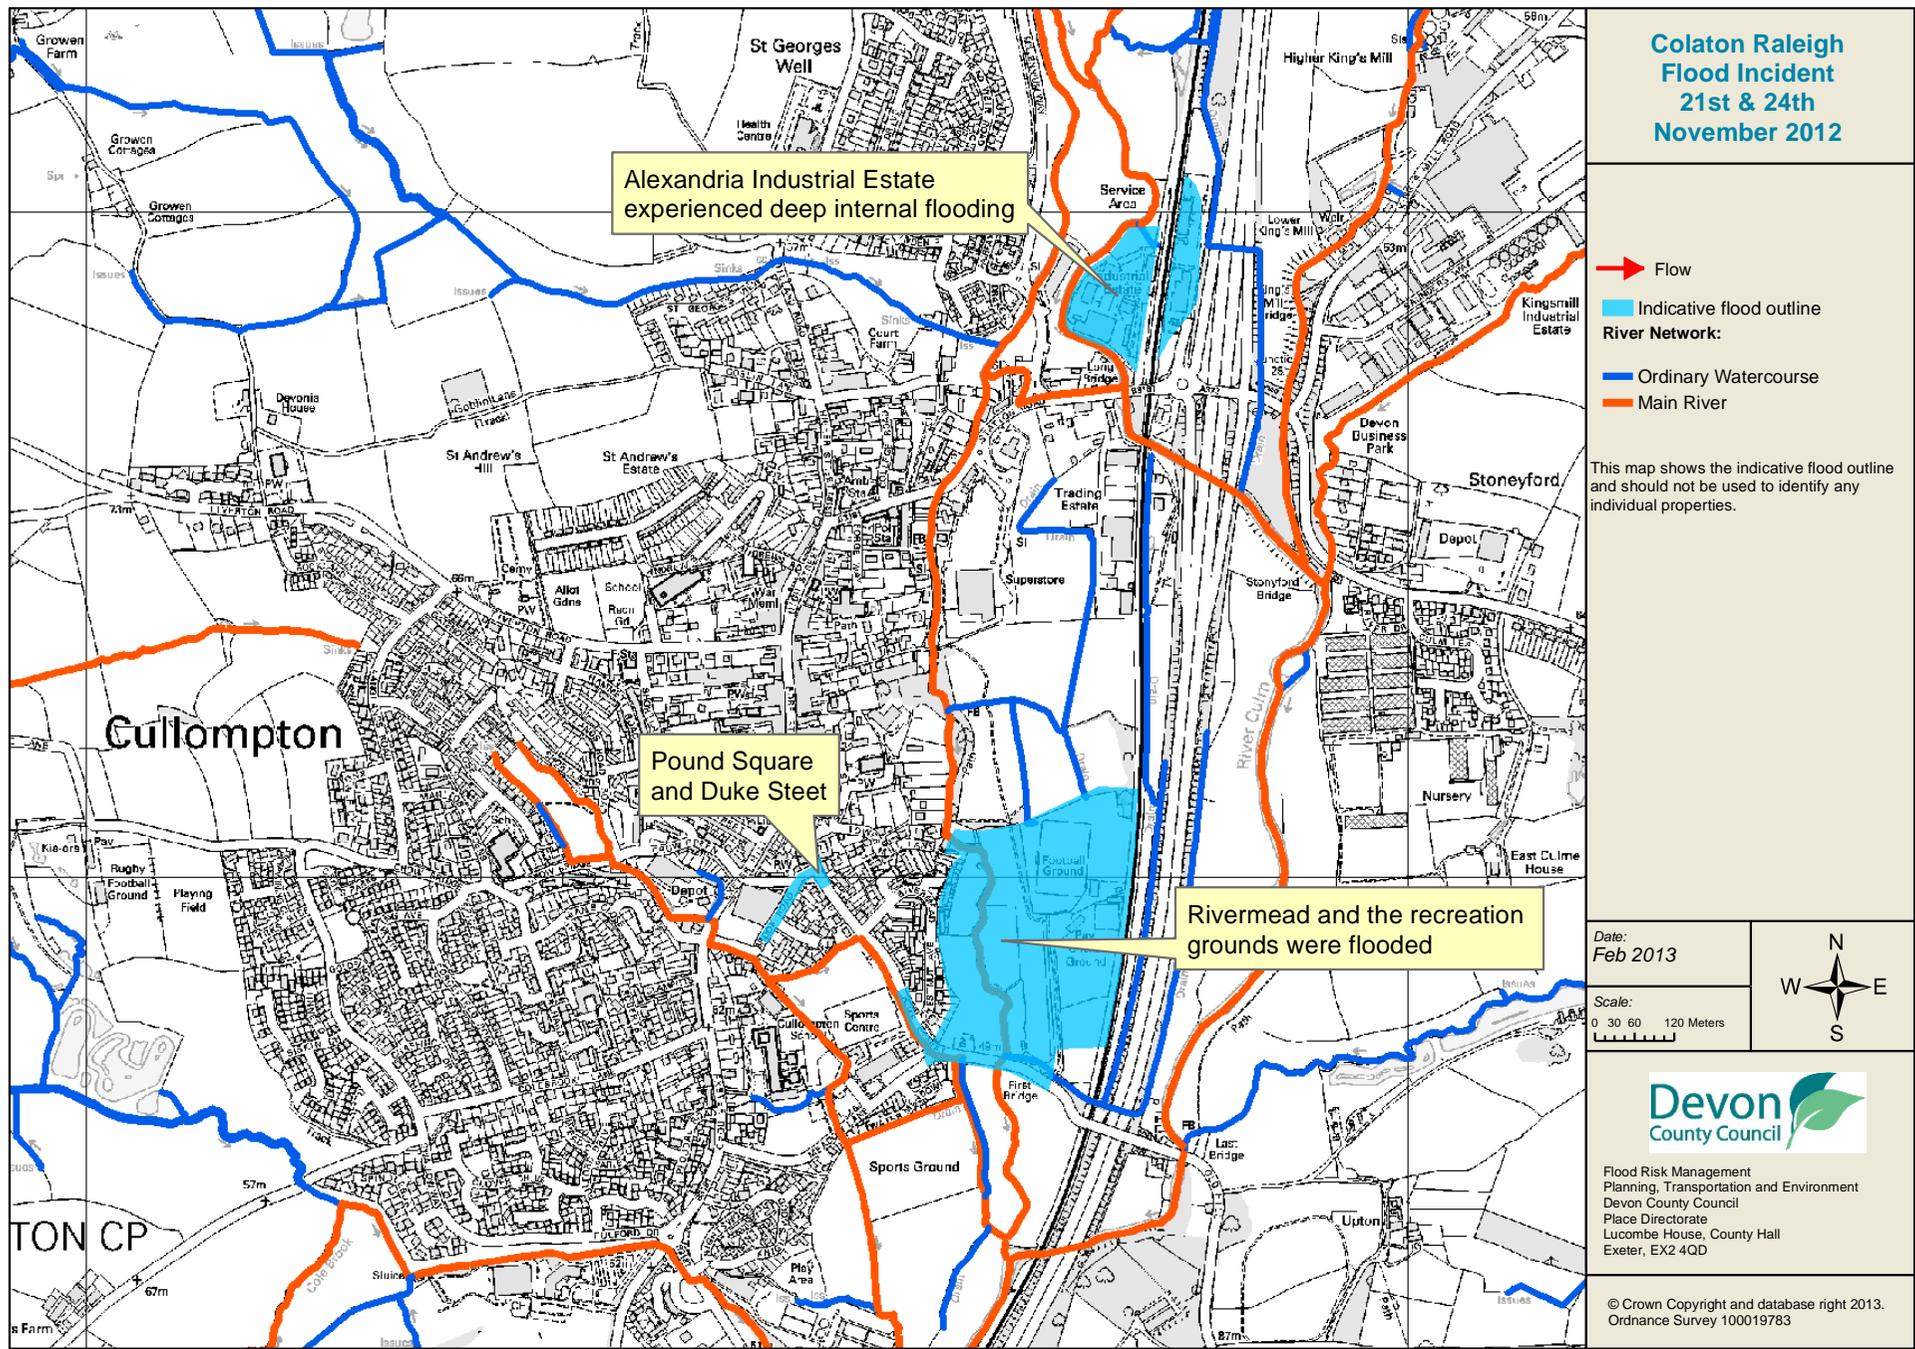
Waters from the Crow Green Stream flowed over Exeter Road, Cullompton on the morning of the 21<sup>st</sup> November causing flooding along Brook Road, Pound Square and Meadow Lane. It is also possible this occurred on the evening of the 24<sup>th</sup> November.

Waters from a tributary of the Cole Brook flooded out of bank at the road bridge on Colebrooke Lane and through the residential estate to the Exeter Road roundabout at Knightswood and Heyridge Meadow. There are reports that netting on the bridge, presumably for stock control, blinded with material which exacerbated the problem. It was also reported that sewage occurred in the surface water at Knightswood.

Figure 9.1. November flood extent and impact in Cullompton

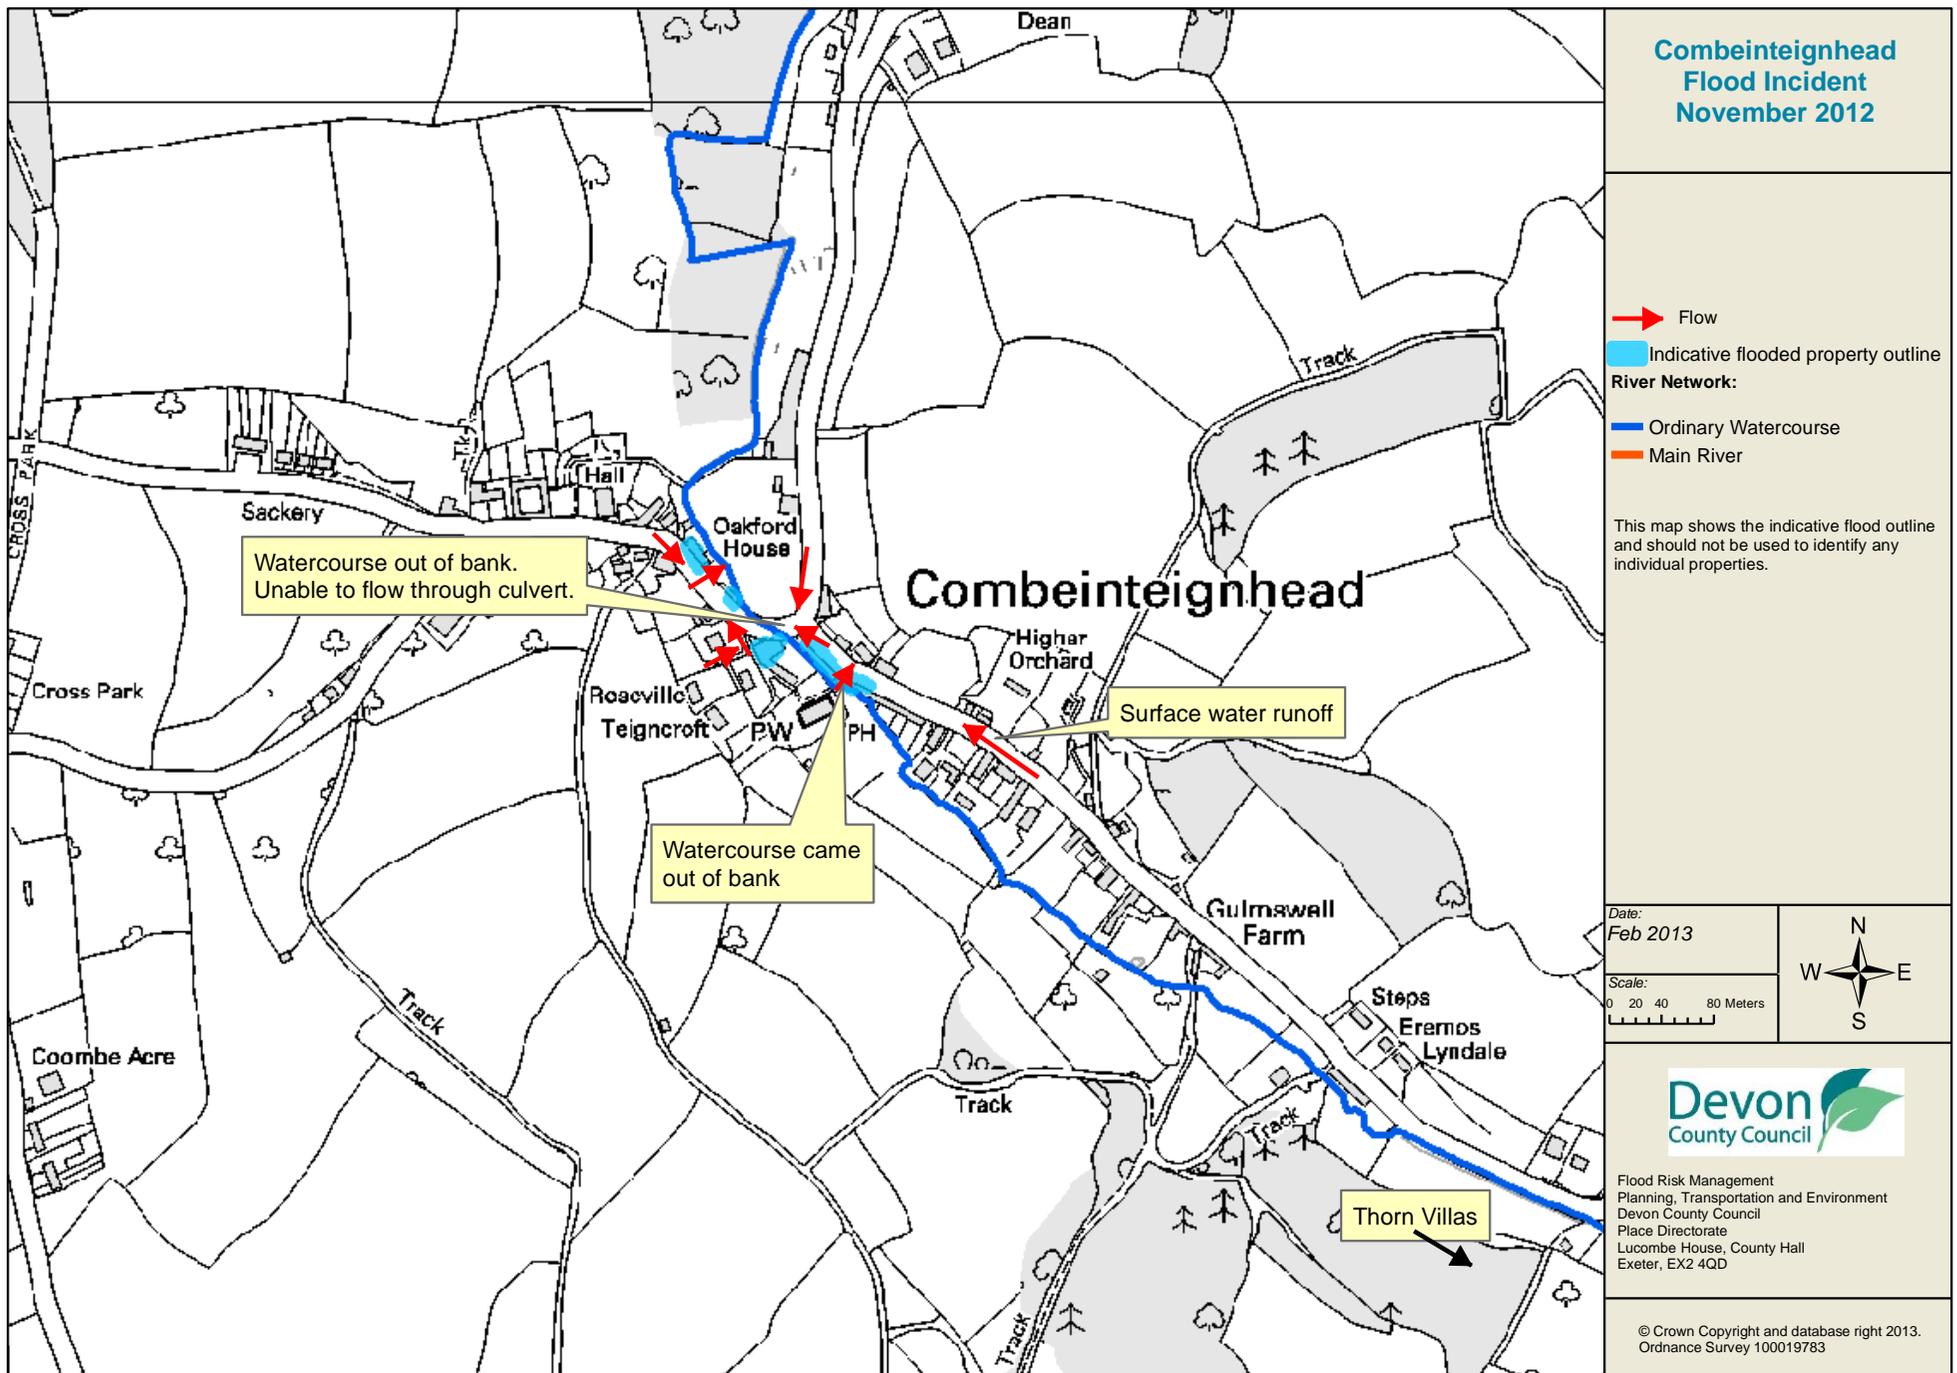
Figure 12.1. November flood extent and impact in Combeinteignhead

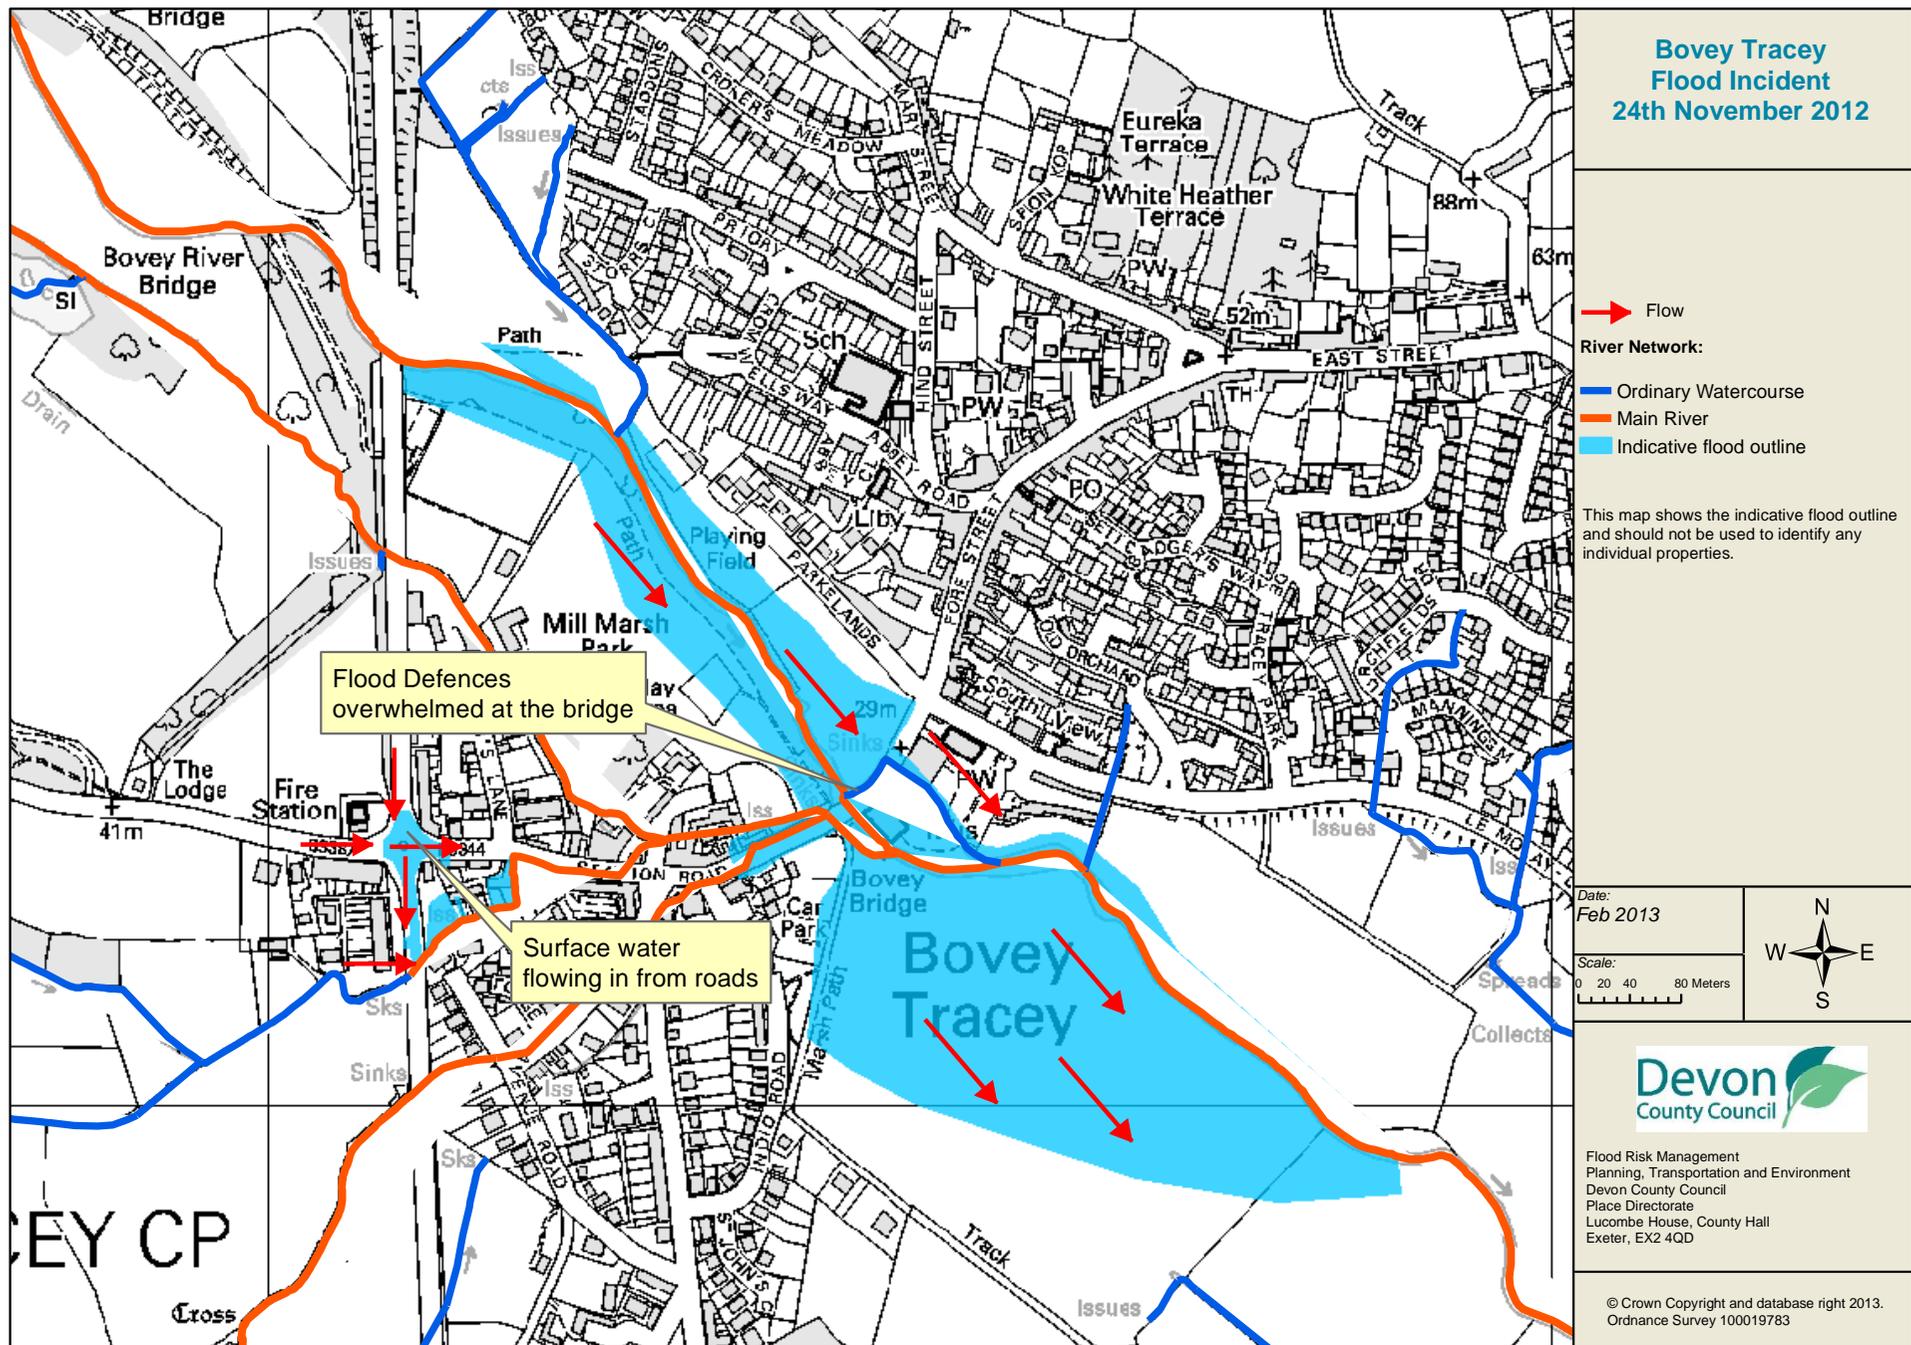
A total of 8 residential properties and 4 commercial premises were affected by internal flooding. Figure 12.1 shows the extent of the flooding in Bovey Tracey.

Figure 12.1. November flood extent and impact in Bovey Tracey

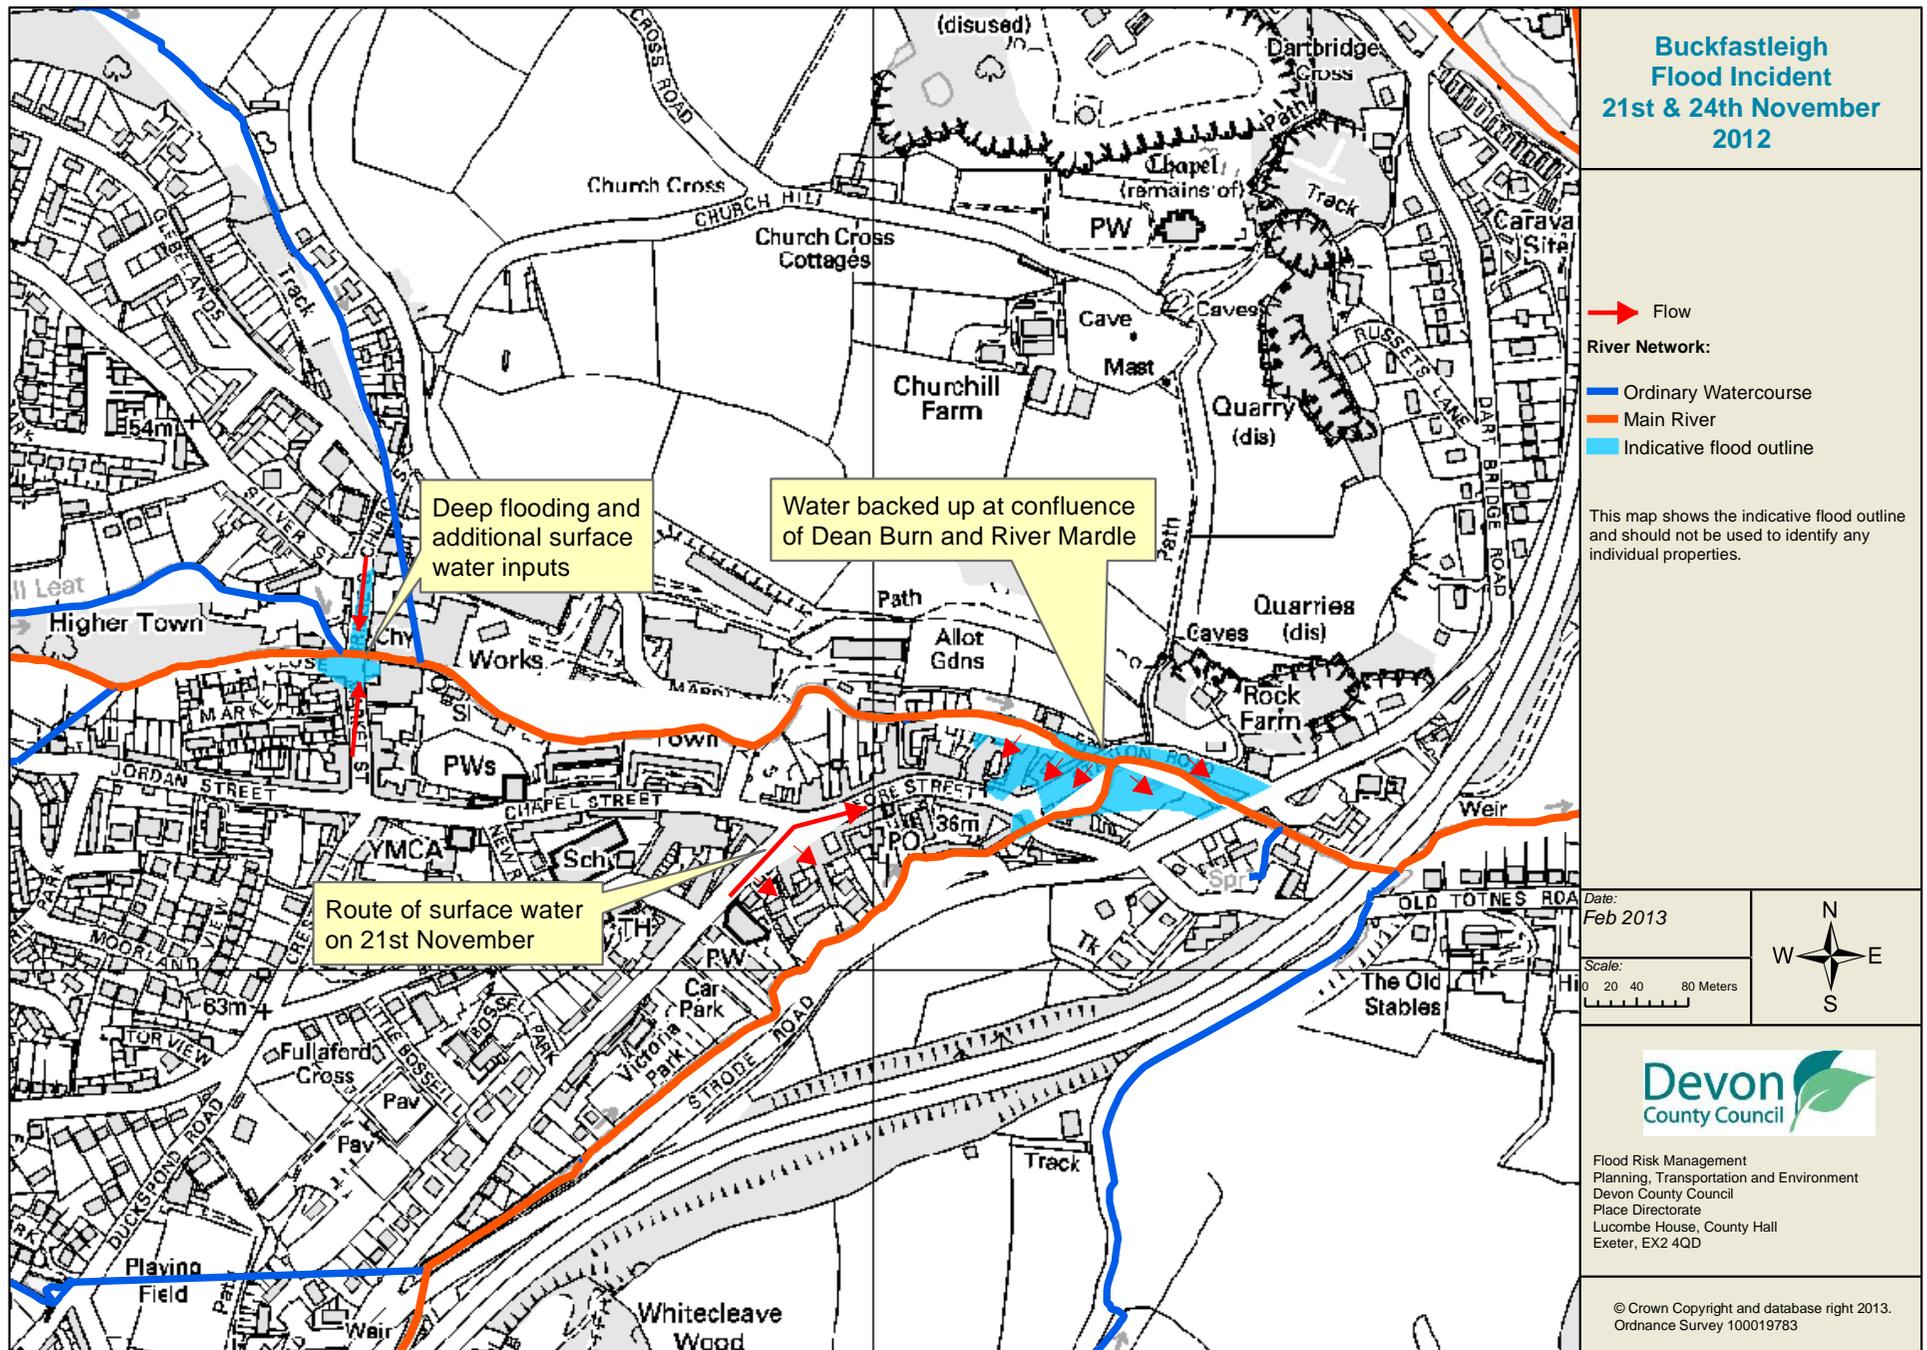
A total of 32 properties were internally flooded over the two flood events with at least a further 3 being affected by the flooding. Cars in the car park were also damaged as a result of the floods. Figure 14.1 shows the extent of the flooding in Buckfastleigh.

Figure 14.1. November flood extent and impact in Buckfastleigh

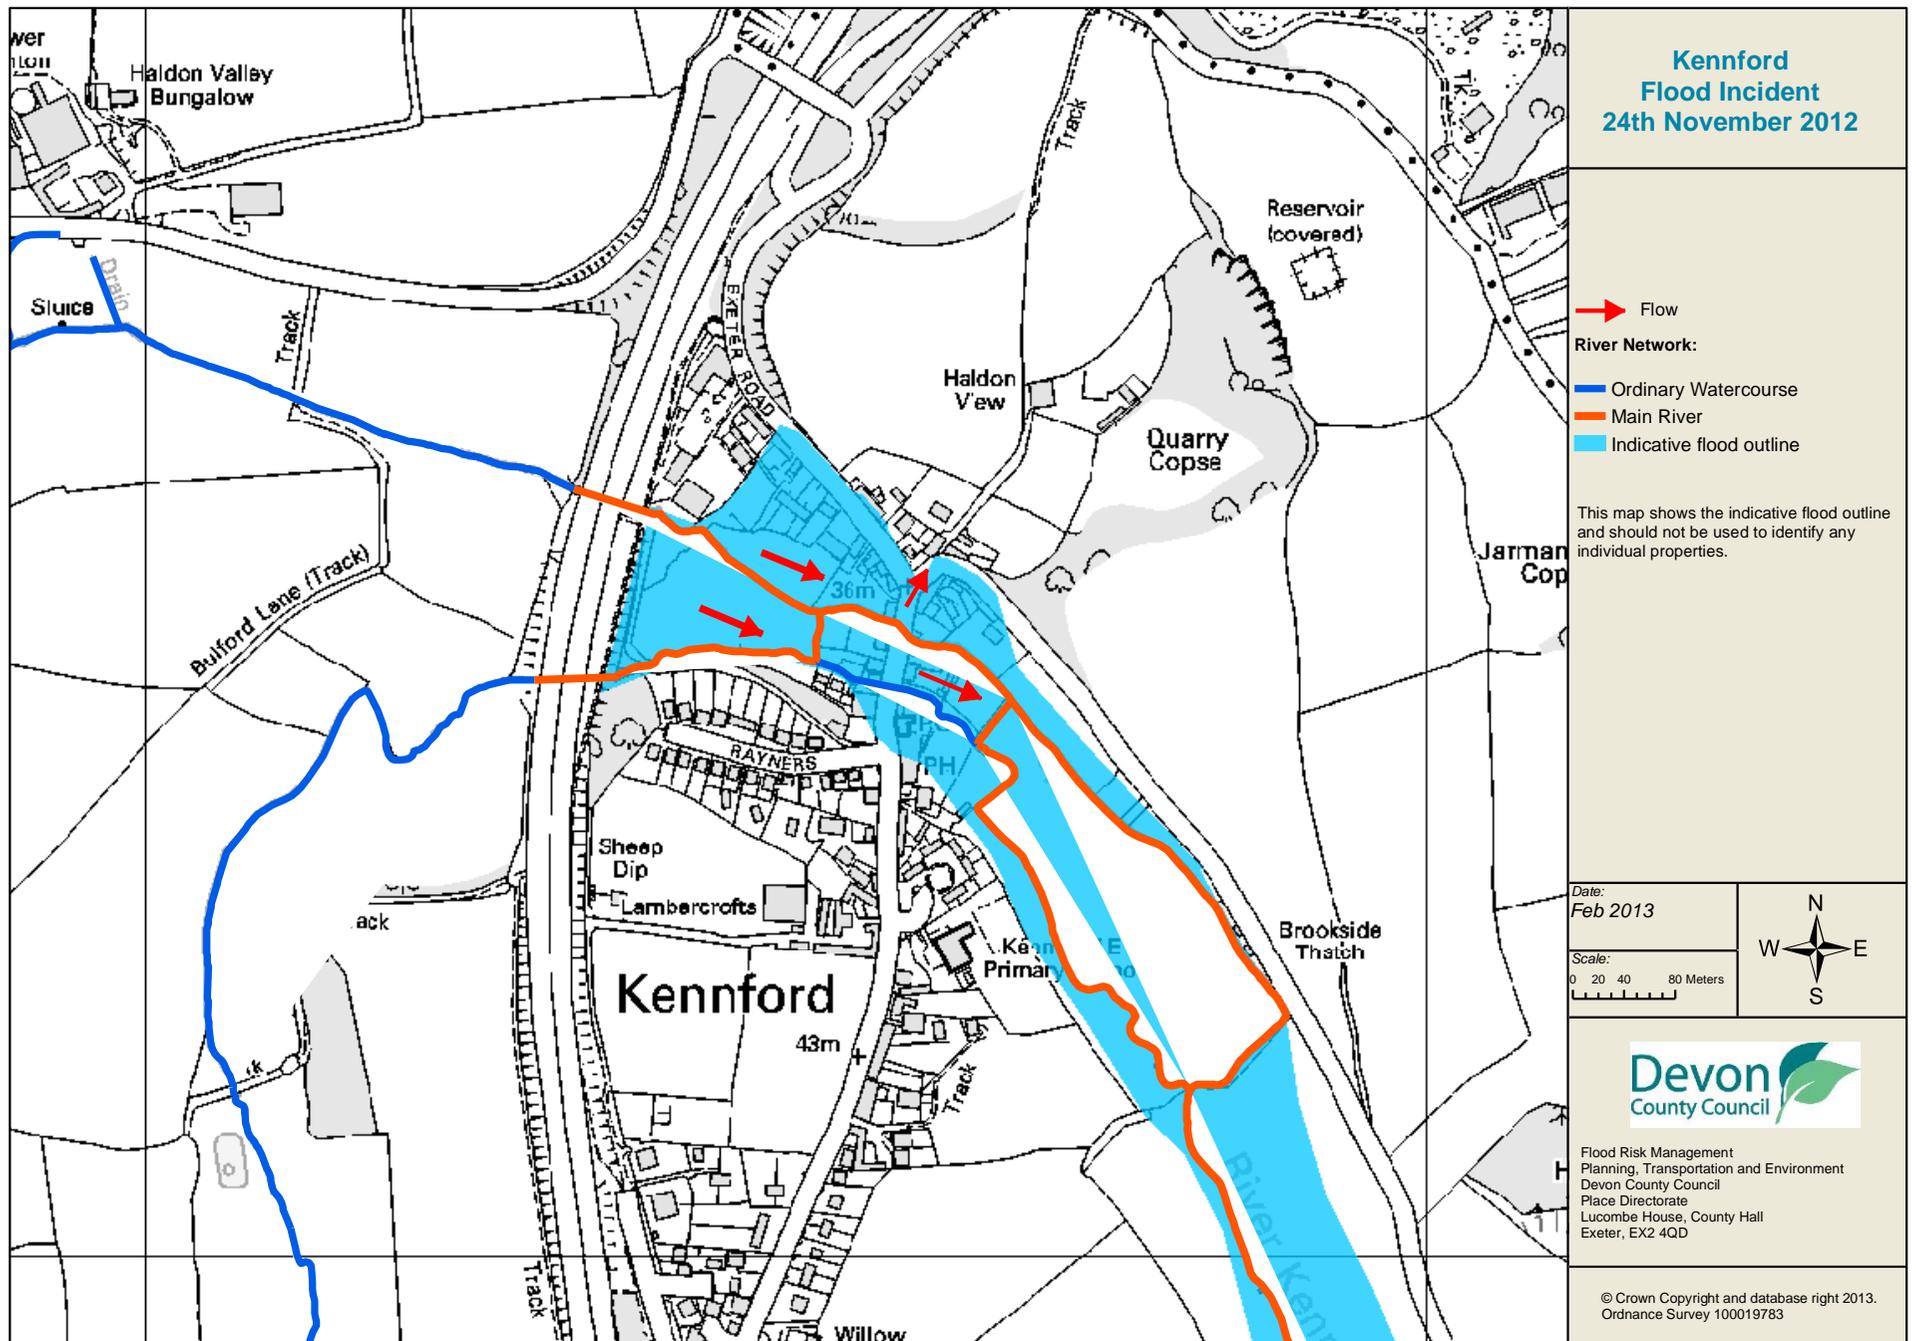
Figure 15.1. November flood extent and impact in Kennford
